NWHC REPORT 7684
30 JUNE 1977

**TEST AND EVALUATION
OF
CONTAINER MK 619 MOD O
FOR
HARPOON GUIDANCE SECTION AN/DSQ-28**

This report details the test and evaluation of a prototype container Mk 619 Mod 0 designed to protect a HARPOON Guidance Section AN/DSQ-28 from the hazards and environments associated with transportation and handling. Test results indicated that with the adoption of two minor design changes pertaining to handling and closure, the container can adequately perform its intended function.

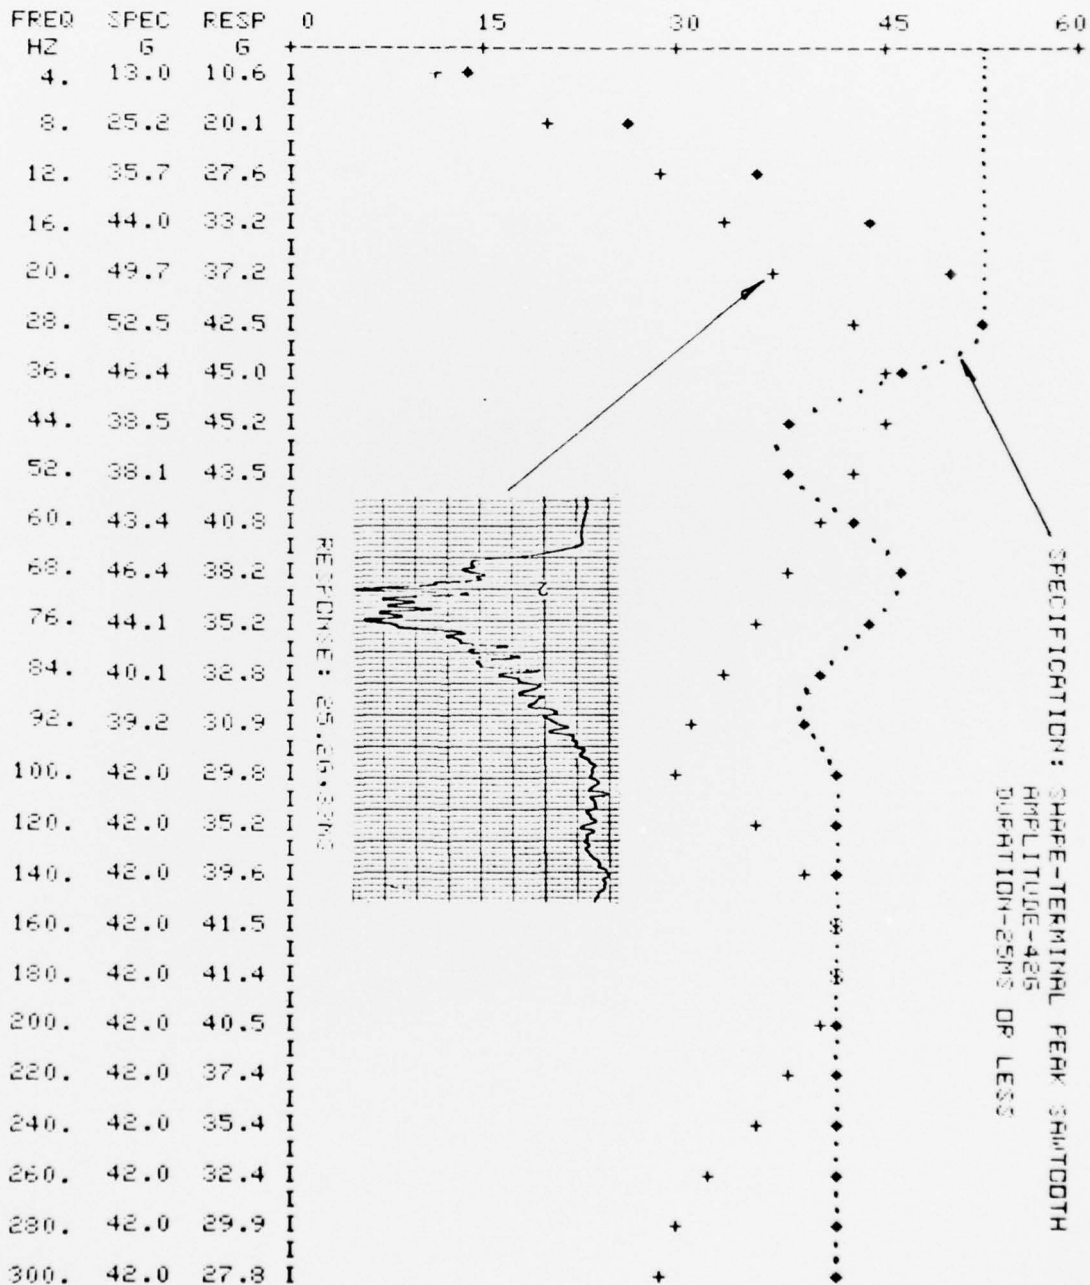
FIGURE 13
CONTAINER MK619 MOD0
36 INCH ROTATIONAL CORNER DROP AT -20F

SHOCK SPECTRUM
SPECIFICATION = ♦
RESPONSE = +

shock was generated and compared to the allowable spectrum. This comparison presented as Figure 13 shows that the spectrum of the most severe of the thirteen response pulses exceeds the allowable spectrum in the frequency range 40-55 Hz. The interpretation of this condition is that the response pulse has greater damage potential to Guidance Section components which have resonances between 40 and 55 Hz than the specification pulse. This is only significant, therefore, if such components exist and cannot survive shock approximately 15% in excess of the design level. In addition, the containerized Guidance Section must experience a 36 inch impact of its corner on a non-yielding surface at -20°F. Since these circumstances are highly unlikely to occur, this out of specification condition is not considered to be important. Shock spectra for other shocks were not computed because of their significantly lower amplitudes.
